Manhole Inspection Summary

Manhole # S4300_012MH

Location Address: **Cliftview Ave**

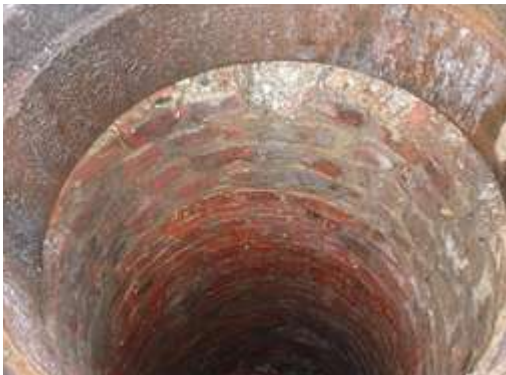
Defect 1

Infiltration: ☐ None ☒ **Joint** ☒ **Cracks** ☐ Mortar ☐ Roots ☐ Wall

Infiltration

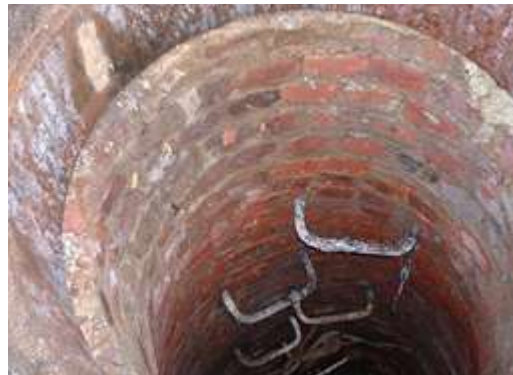
Defect 2

☒ **Leaks**

Frame leaks

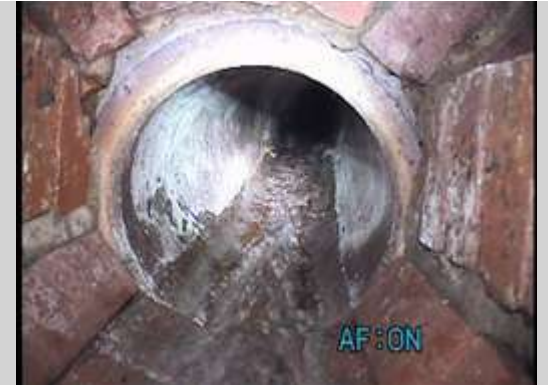
12 O'Clock Outflow

8 in. Circular Gravity Sewer
Pipe Out @ 12 O'Clock

Pipe Height: **8.4** (in.) Rod and Bar (Angled)
Pipe Material: **Clay** ☐ Pipe Lined
Invert Depth: **10.80** (ft.) Flow Characteristics: **Fast**
Deposits: ☒ None ☐ Mud ☐ Sludge ☐ Debris ☐ Grease
Silt Depth: (in.) Deposits Extent:
Infiltration: **None** Pipe Seal Cond: **Sound**

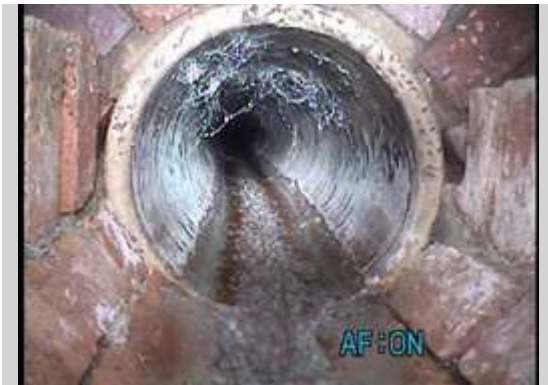
6 O'Clock Inflow

8 in. Circular Gravity Sewer
Pipe In @ 6 O'Clock

Pipe Height: **8.4** (in.) Rod and Bar (Angled)
Pipe Material: **Clay** ☐ Pipe Lined
Invert Depth: **10.30** (ft.) Flow Characteristics: **Fast**
Deposits: ☒ None ☐ Mud ☐ Sludge ☐ Debris ☐ Grease
Silt Depth: (in.) Deposits Extent:
Infiltration: **None** Pipe Seal Cond: **Sound**
